Casualty Information

Information from DNV to the maritime industry No. 6 September 2006

Open lifeboat – corroded tie band side plates!

Ship type: Any Size (grt): Any Year built: 1983

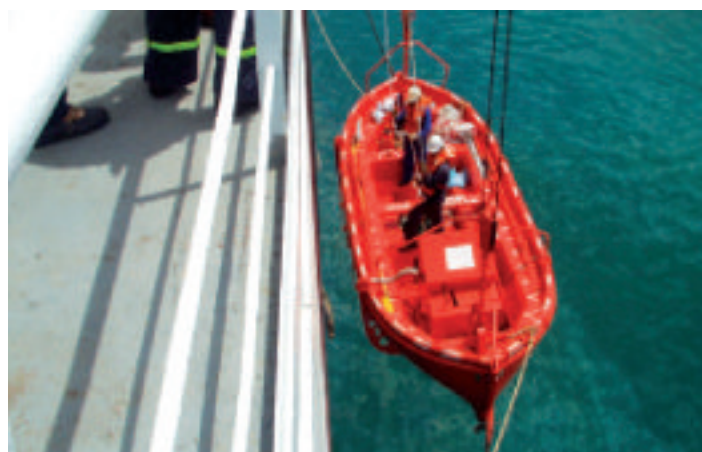
Fig. 1: For reference only!

The empty port lifeboat was lowered to the embarkation platform, see Fig. 1, when the aft boat hook tie band gave way from its attachment to the boat keel.

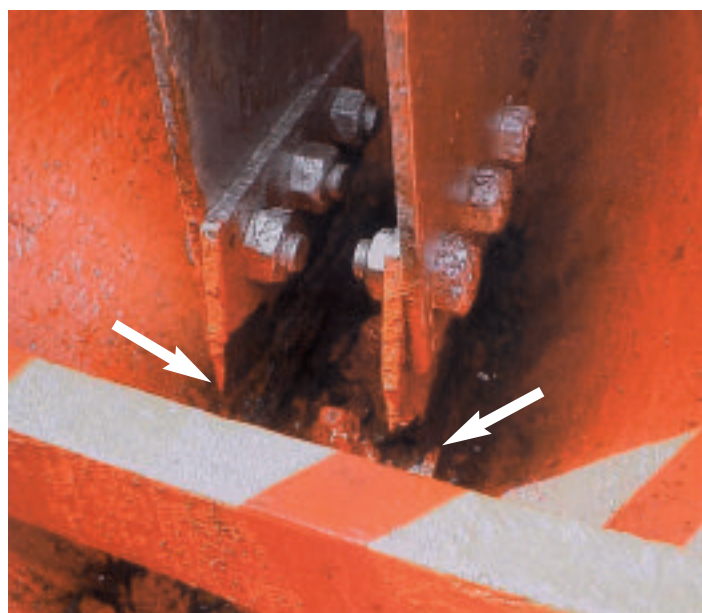
In connection with davit tests on one ship, tie band side plates in the lifeboats were checked and found heavily corroded. Forward tie band side plates of one boat were completely wasted. It was well painted and thus looked well preserved but by hammering, an open gap of approx. 10 mm was revealed, see Fig. 2. Immediate repairs were required.

Launching of this boat with people could have caused fatalities.

Fig. 2: Serious corrosion of tie band side plates at connection to the bottom of the lifeboat. An open gap of approx. 10 mm may be seen!

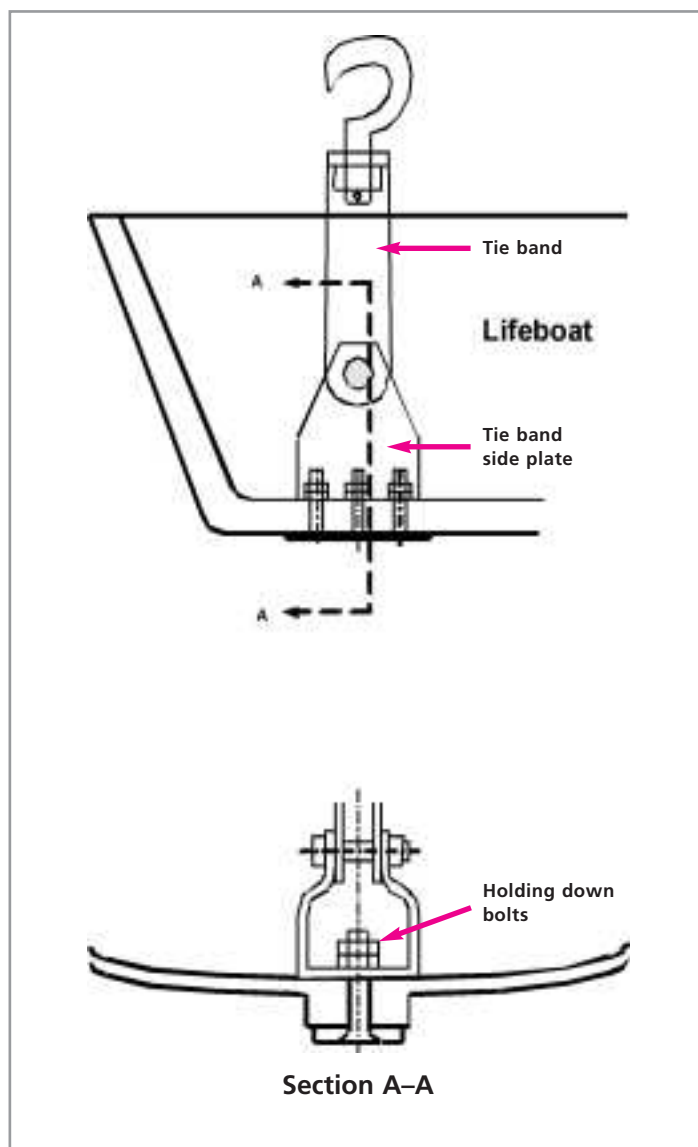
During inspection of another lifeboat, equipment was removed forward and aft for access to the bottom of the boat. In this case the tie band side plates were connected to the boat with three bolts and with one counter-nut per bolt as shown in Fig. 3.

By chipping and scaling out the nuts, they were found extremely corroded and partly missing and the boats were subject to immediate repairs.

Fig. 3: Tie band side plates connected to the boat with three bolts and with one counter-nut per bolt.
