NAUTICUS HULL STATUS LIST

NOVEMBER 2011 RELEASE

LATEST UPDATE: 13 JANUARY 2012

DET NORSKE VERITAS

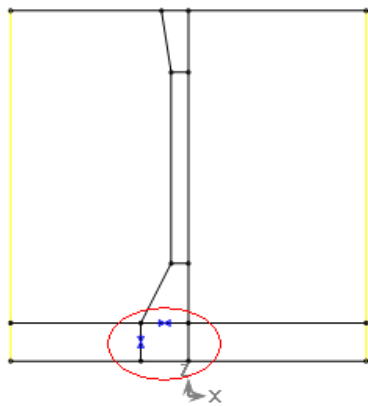
This is supported:

- . **Merged compartments caused by cut-outs in transverse bulkheads**
In general cut-outs will automatically merge adjoining compartments. Cut-outs in transverse bulkheads should merge compartments in longitudinal structures and compartments in transverse stool tanks.

However, if non-watertight bulkheads because of cut-outs, i.e. the compartment aft of the bulkhead and compartment forward of the bulkhead should be merged, then this will not work. Such compartments must be joined manually.

Merge of a stool tank and the adjoining compartment will however work properly, see figure:

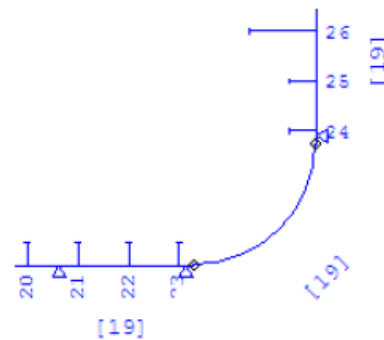
Supported configuration:
Stiffener at transition point.

Not supported configuration:
Stiffener not at transition point
