Engine room fires can be avoided

DNV FOCUS: ENGINE ROOM SAFETY – CHALLENGES AND SOLUTIONS

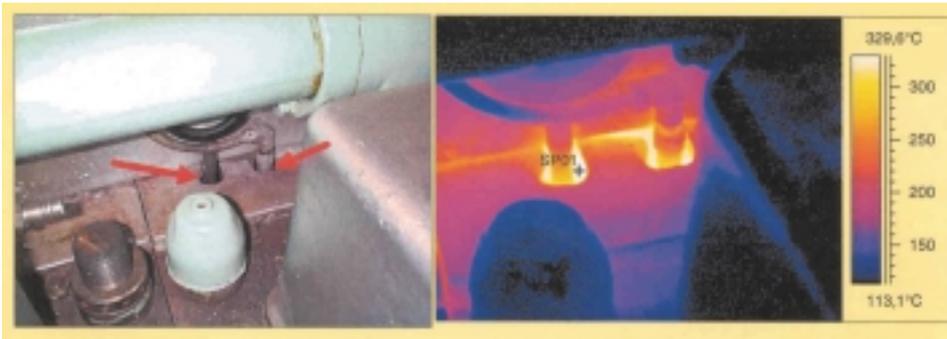
Most fuel oils may spontaneously ignite if they hit surfaces with temperatures above 250°C. Class rules require that all surfaces above 220°C are to be shielded or insulated.

As commonly noted by our surveyors, such protection is often impaired under operation. Several methods can be used to detect hot surfaces – for more information see enclosed DNV Paper.

The picture shows cylinder hoods and engine body (only 100°C) and cut out for sensors (more than 300°C).

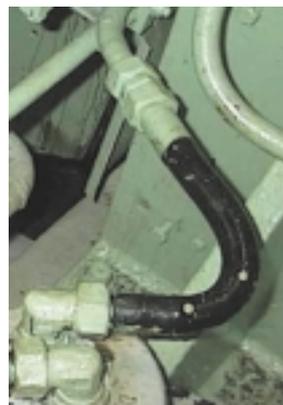
Sources of fuel leakage appear to be randomly distributed between flexible hoses, couplings, clogged filters and fractured pipes. Attention should be paid to installation, location and condition of all these components.

Flexible hoses should only be installed where necessary to absorb vibrations. Bends on oil hoses, sharper than that shown on this picture, should be avoided.
