Casualty Information

Information from DNV to the maritime industry No. 3 May 2006

Fatal accident with lifting appliance

Ship type: Any Size (grt): Any Year built: Any

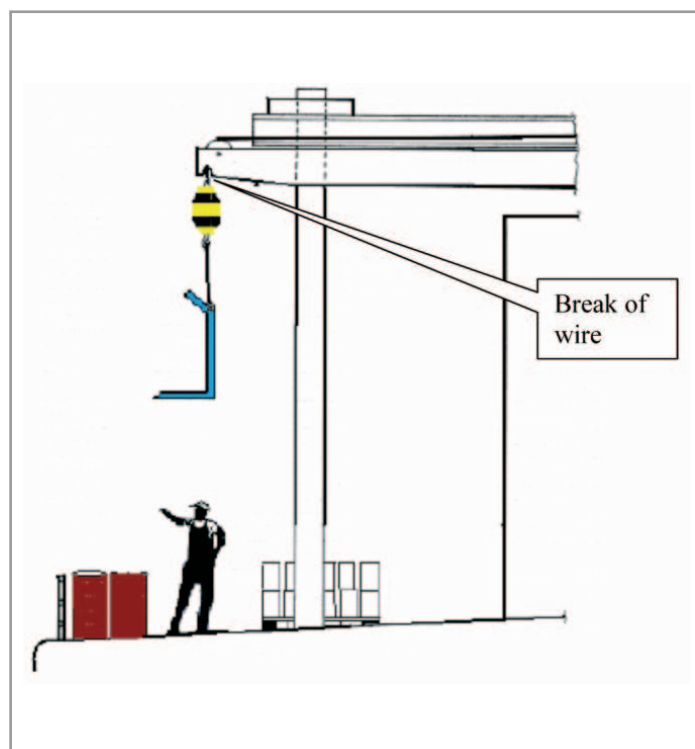
A provision crane loaded pallets onboard a vessel using a pallet fork. After landing the pallet on the vessel's deck, the pallet fork was cleared and the crane operator moved the crane outward to pick up new load. During this operation, the crane wire broke and the pallet fork and the hook fell down and hit one of the crewmembers on the vessel.

Fig. 1: Sketch of the lifting equipments.

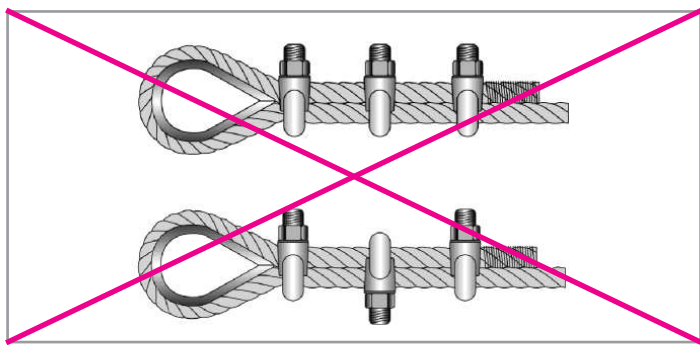
1. Malfunction/missing upper limit switch. If the upper limit switch had been operational, it would have stopped the movement before the hook was able to hit into the crane beam.
2. The wire end at the hook side was terminated by means of three incorrectly applied U-bolt clamps (see Fig. 2) instead of a ferrule lock device as prescribed in Maker's manual (see Fig. 3). Tests has shown that this lead to a considerable reduction of the breaking strength of the wire resulting in a breaking strength below the loading in the wire when the hook blocks hits into the crane beam with full hoisting speed.

Fig. 2: Incorrect methods of attaching clamps to wire rope. The below method was used in this case. The pictures are copied from CASAR Special wire ropes, Wire Rope End Connections.

2. Assure that wire end terminations are correctly performed. Note that DNV rules do not allow the use of U-clamps, but properly designed clamps with two gripping areas are accepted, see Fig. 4.

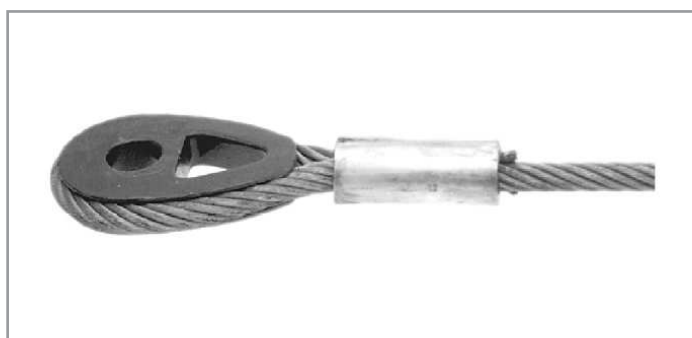
Fig. 3: Example of a ferrule lock suggested in makers manual. The picture is copied from CASAR Special wire ropes, Wire Rope End Connections.

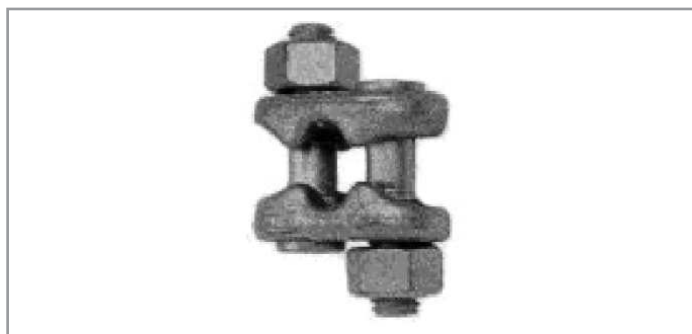
Fig. 4: Example of acceptable wire rope clamp with two gripping areas. Figure from The Crosby Group Inc, General Catalog 2005.
